**Flood Control Project Maintenance
Levee Inspections**

Maintenance Issue Types Only, Levee Inspection Report By Mile - Fall 2019

Reclamation District No. 2060 Hastings

Waterway	Bank	Unit Miles	Inspection Start/End	Inspector
Unit No. 01 Lindsey Slough	Left	6.97	10/15/2019 10/15/2019	David Julian

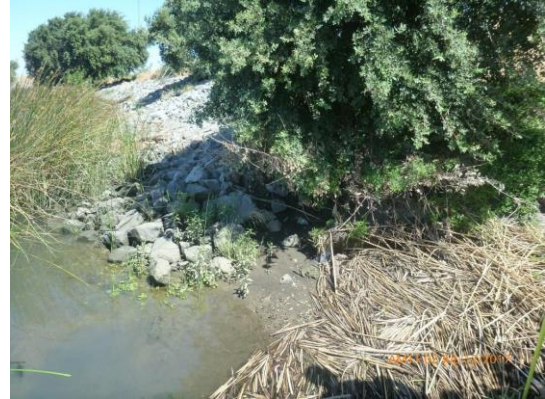
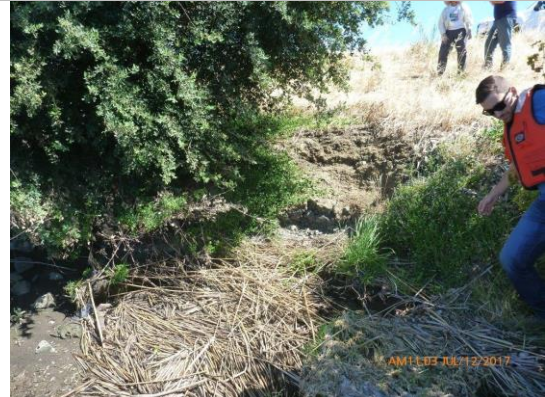
LM Start	0.41	Rating **	M	Issue No.	8 (cont)	
LM End	0.42	Issue Type +	Ma	Location *	WS	
Category	Supplemental			GPS Latitude/Longitude		
				Start	End	
Item	2017 Storm Damage			38.248036 °	38.248017 °	
				-121.703539 °	-121.703789 °	
DWR ID	LMA-186					
Comment Code						
Inspector Comment						
Levee Evaluation Comments						
Description:Erosion commences approximately halfway down the water side slope extending in to existing rip rap. Existing rip rap appears to have been pulled off in this section.						
Site ID No:359						
Site Designation:LMA-186						
Repair Type: Erosion						
Rating:Area of Concern						
Field Date:7/12/2017						
Notes: Site had riprap but is eroded away. Minor erosion in toe of levee.

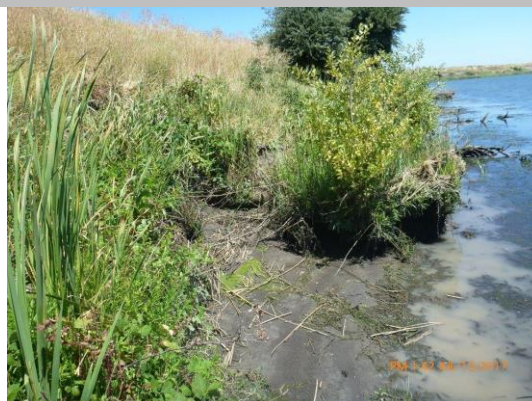
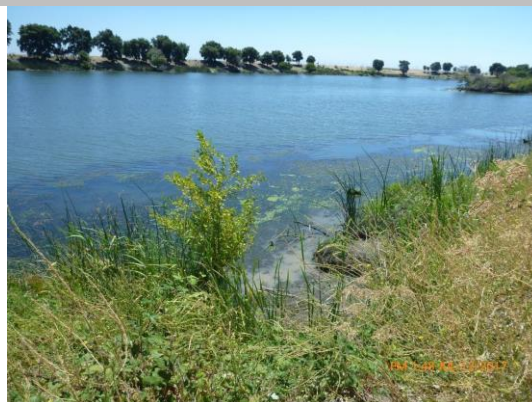
LM Start	1.09	Rating **	M	Issue No.	16 (cont)
LM End	1.10	Issue Type +	Ma	Location *	WS
Category	Supplemental			GPS Latitude/Longitude	
				Start	End
Item	2017 Storm Damage			38.250844 °	38.250833 °
				-121.714944 °	-121.714994 °
DWR ID	LMA-190

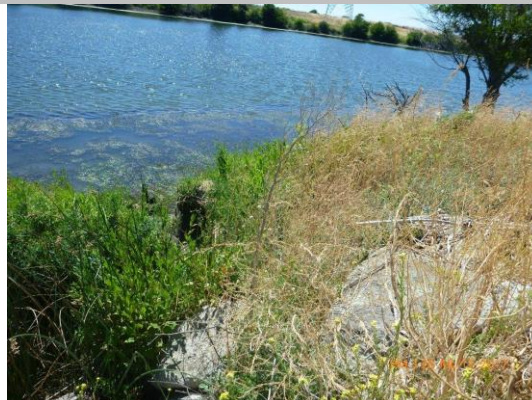
LM Start	1.81	Rating **	A/W	Issue No.	21
LM End	1.84	Issue Type +	Ma	Location *	WS
Category	Supplemental			GPS Latitude/Longitude	
				Start	End
Item	2017 Storm Damage			38.255972 °	38.256247 °
				-121.724197 °	-121.724464 °
DWR ID	LMA-193

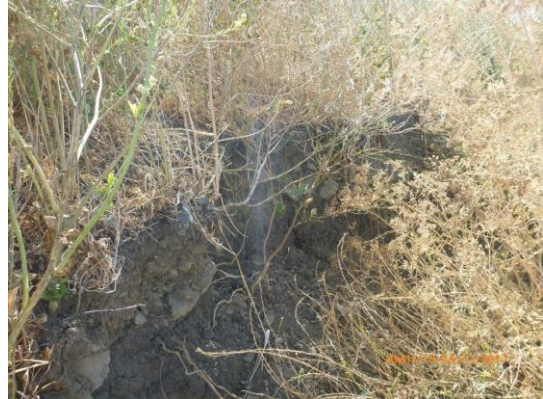
Photo 1 of 3 : FA_2019_RD2060_241_23_20190826_00032.jpg

LM Start	2.10	Rating **	A/W	Issue No.	23
LM End	2.13	Issue Type +	Ma	Location *	
Category	Supplemental			GPS Latitude/Longitude	
				Start	End
Item	2017 Storm Damage			38.259317 °	38.259258 °
				-121.726314 °	-121.726939 °
DWR ID	LMA-195				
Comment Code					
Inspector Comment					
Levee Evaluation Comments					
Description:Erosion commences approximately halfway down the water side slope extending to the rip rap.					
Site ID No:368					
Site Designation:LMA-195					
Repair Type: Erosion					
Rating:Serious					
Field Date:7/13/2017					
Notes: Erosion appears to be previously repaired, but has failed again.

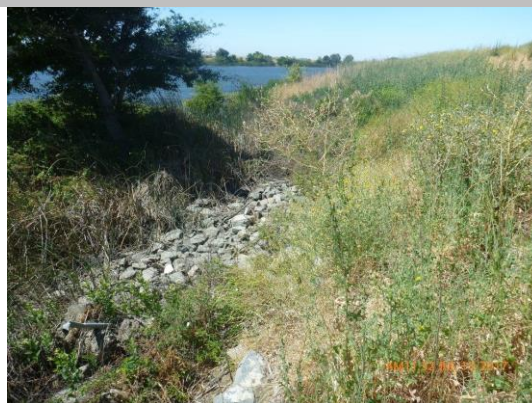
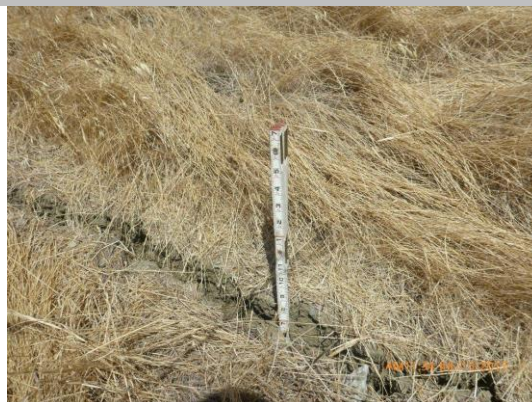
Notes: Large erosion halfway into levee. Horizontal cracking on slope almost 24" deep.

LM Start	3.07	Rating **	A/W	Issue No.	25 (cont)
LM End	3.10	Issue Type +	Ma	Location *	WS
Category	Supplemental			GPS Latitude/Longitude	
				Start	End
Item	2017 Storm Damage			38.260772 °	38.260569 °
				-121.740817 °	-121.741194 °
DWR ID	LMA-197				
Comment Code					
Inspector Comment					
Levee Evaluation Comments					
Description:Erosion occurs near the waterline. Part of the levee has sloughed down toward the waterline due to erosion.					
Site ID No:370					
Site Designation:LMA-197					
Repair Type: Erosion					
Rating:Serious					
Field Date:7/13/2017					
Notes: Large erosion halfway into levee. Horizontal cracking on slope almost 24"deep.

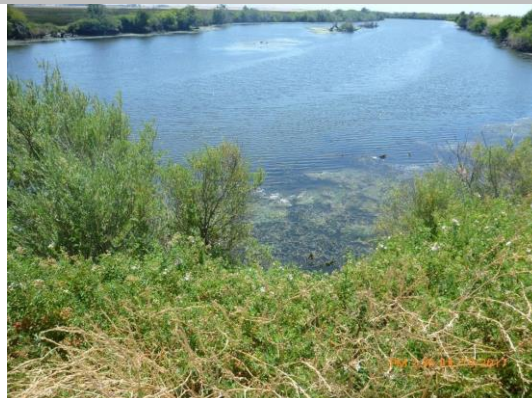
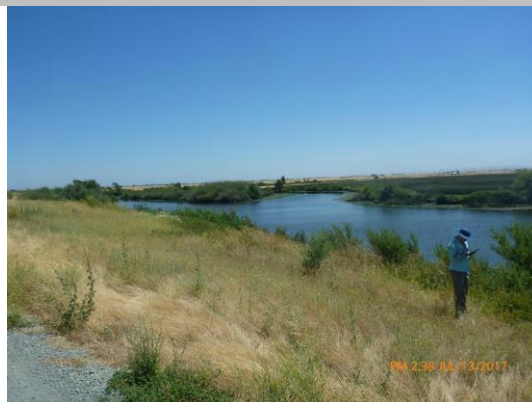
LM Start	4.28	Rating **	A/W	Issue No.	29
LM End	4.28	Issue Type +	Ma	Location *	WS
Category	Supplemental		GPS Latitude/Longitude		
			Start	End	
Item	2017 Storm Damage		38.260992°	38.261017°	
			-121.759806°	-121.759847°

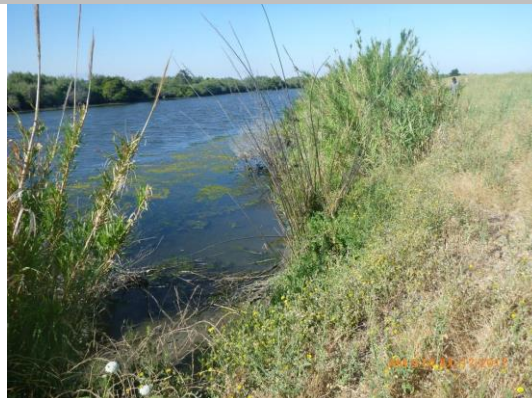
LM Start	4.50	Rating **	A/W	Issue No.	31
LM End	4.53	Issue Type +	Ma	Location *	WS
Category	Supplemental			GPS Latitude/Longitude	
				Start	End
Item	2017 Storm Damage			38.260150°	38.259939°
				-121.763556°	-121.764064°
DWR ID	LMA-205				
Comment Code					
Inspector Comment					
Levee Evaluation Comments					
Description:Erosion commences approximately 3/4 of the way down the slope. It has resulted in some sloughing.					
Site ID No:378					
Site Designation:LMA-205					
Repair Type: Erosion					
Rating:Serious					
Field Date:7/17/2017					
Notes: Deep, wide, vertical cut into slope almost 1/2 way into sope.

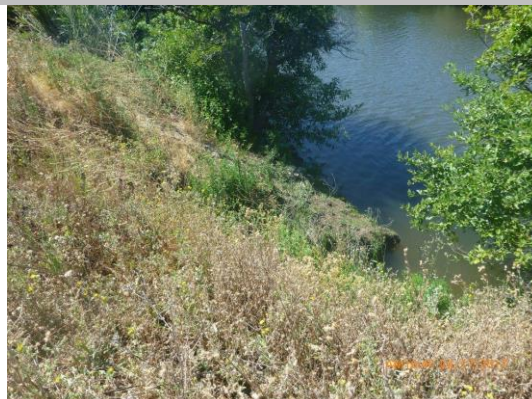
Photo 1 of 3 : FA_2019_RD2060_241_34_20190826_00065.jpg

LM Start	5.00	Rating **	M	Issue No.	34
LM End	5.01	Issue Type +	Ma	Location *	WS
Category	Supplemental			GPS Latitude/Longitude	
				Start	End
Item	2017 Storm Damage			38.262636 °	38.262658 °
				-121.770503 °	-121.770547 °
DWR ID	LMA-208				
Comment Code					
Inspector Comment					
Levee Evaluation Comments					
Description:Erosion is concentrated mostly near the water line and has resulting in slippage of the slope into the toe.					
Site ID No:381					
Site Designation:LMA-208					
Repair Type: Erosion					
Rating:Area of Concern					
Field Date:7/17/2017					
Notes: Extended site from 15' to 75' to include LMA-209. Small erosions will become 1 site next high water due to sloughing between them.

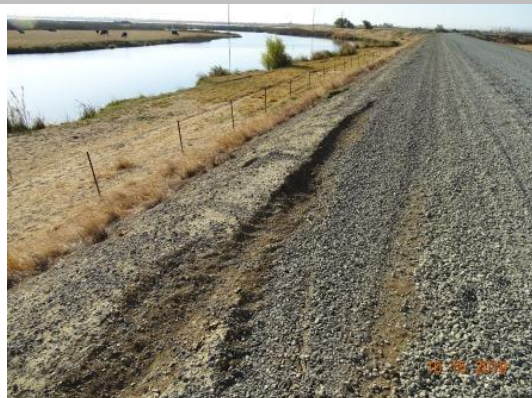
Photo 1 of 1 : FA_2019_RD2060_242_6_20191015_00011.jpg

View of deep rut on the waterside shoulder of the crown (Fall 2019).

LM Start	0.22	Rating **	M	Issue No.	6
LM End	0.22	Issue Type +	Ma	Location *	CR
Category	Earthen Levee			GPS Latitude/Longitude	
				Start	End
Item	Crown Surface / Depressions / Rutting			38.277807 °	38.277807 °
				-121.795928 °	-121.795928 °
DWR ID	DWR_RD2060_02_f_2019_6				
Comment Code					
C2 : Repair depressions or ruts in the crown or slope.					
Inspector Comment

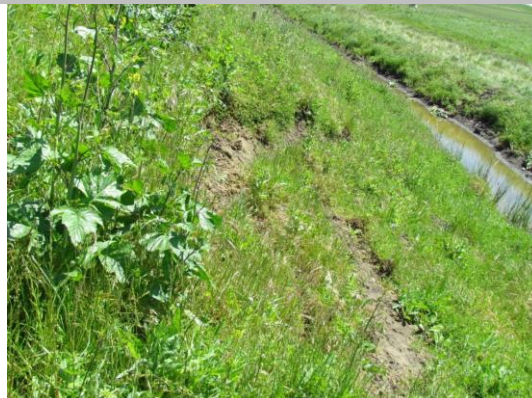
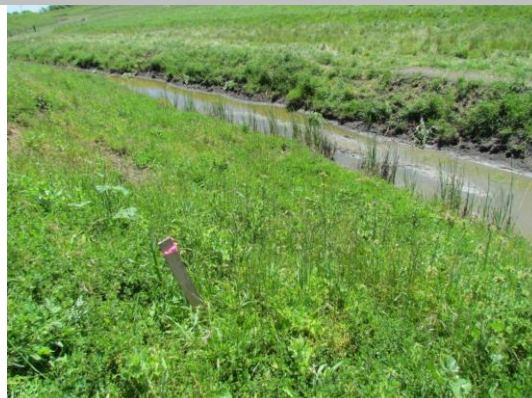
LM Start	0.15	Rating **	A/W	Issue No.	19 (cont)	
LM End	0.19	Issue Type +	Ma	Location *	LS	
Category	Earthen Levee			GPS Latitude/Longitude		
				Start		End
Item	Slope Stability			38.295738 °		38.295559 °
				-121.746293 °		-121.745583 °
DWR ID	DWR_RD2060_03_f_2019_19					
Comment Code						
S1 : Repair slope instability.						
Inspector Comment						
There are several signs of sloughing occuring on the slope.

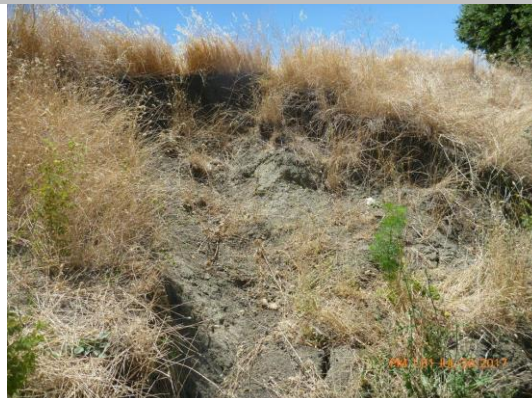
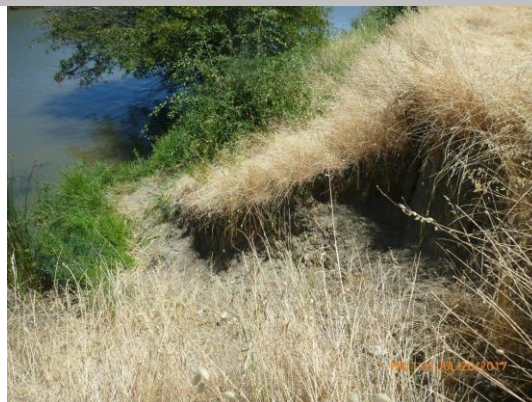
LM Start	0.64	Rating **	M	Issue No.	14
LM End	0.64	Issue Type +	Ma	Location *	WS
Category	Supplemental			GPS Latitude/Longitude	
				Start	End
Item	2017 Storm Damage			38.292197 °	38.292208 °
				-121.739661 °	-121.739611 °
DWR ID	LMA-213				
Comment Code					
Inspector Comment					
Levee Evaluation Comments					
Description:Erosion commences near the edge of the crown and extends down the slope. Erosion has resulted in slippage into the waterside toe.					
Site ID No:386					
Site Designation:LMA-213					
Repair Type: Erosion					
Rating:Area of Concern					
Field Date:7/20/2017					
Notes:

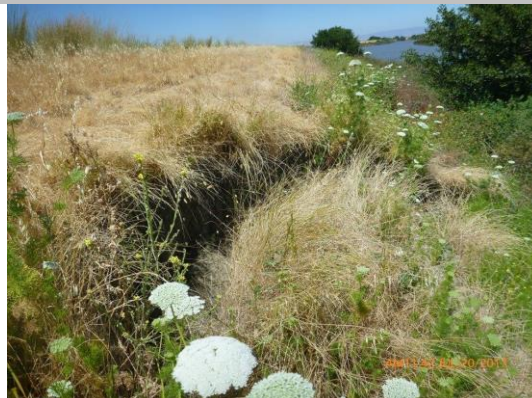
LM Start	1.21	Rating **	M	Issue No.	20
LM End	1.23	Issue Type +	Ma	Location *	WS
Category	Supplemental			GPS Latitude/Longitude	
				Start	End
Item	2017 Storm Damage			38.290511 °	38.290486 °
				-121.729867 °	-121.729603 °
DWR ID	LMA-217				
Comment Code					
Inspector Comment					
Levee Evaluation Comments					
Description:Erosion commences 1/4 of the way down the slope with slippage towards the water side toe.					
Site ID No:390					
Site Designation:LMA-217					
Repair Type: Erosion					
Rating:Area of Concern					
Field Date:7/20/2017					
Notes: Erosion halfway down WS slope. Monitor for progression.

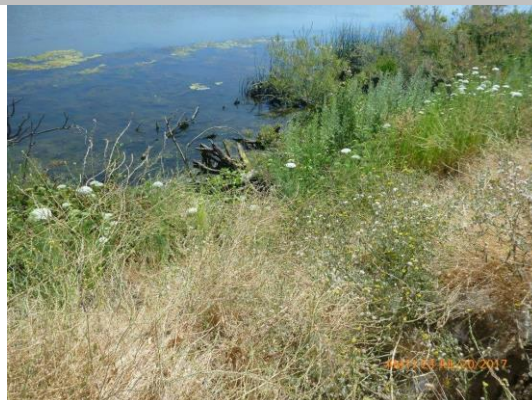
Photo 2 of 3 : FA_2019_RD2060_243_22_20190826_00021.jpg

LM Start	1.45	Rating **	M	Issue No.	22 (cont)	
LM End	1.59	Issue Type +	Ma	Location *	WS	
Category	Supplemental			GPS Latitude/Longitude		
				Start		End
Item	2017 Storm Damage			38.289256 °		38.287689 °
				-121.726050 °		-121.724658 °
DWR ID	LMA-219					
Comment Code						
Inspector Comment						
Levee Evaluation Comments						
Description:Erosion commences halfway down the slope and results in						
slippage into the waterside toe.						
Site ID No:392						
Site Designation:LMA-219						
Repair Type: Erosion						
Rating:Area of Concern						
Field Date:7/20/2017						
Notes: Moderate erosion present on WS slope. Monitor for progression.

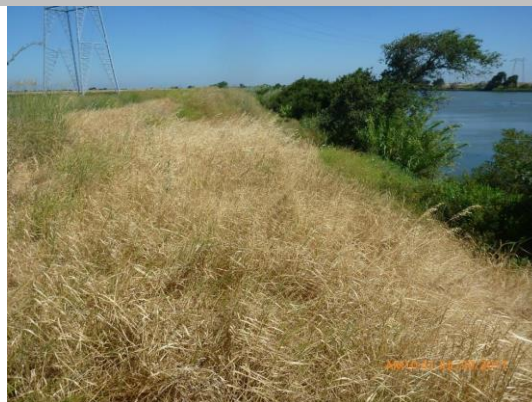
Photo 1 of 3 : FA_2019_RD2060_243_23_20190826_00023.jpg

LM Start	1.62	Rating **	A/W	Issue No.	23
LM End	1.63	Issue Type +	Ma	Location *	WS
Category	Supplemental			GPS Latitude/Longitude	
				Start	End
Item	2017 Storm Damage			38.287336 °	38.287222 °
				-121.724364 °	-121.724253 °
DWR ID	LMA-220				
Comment Code					
Inspector Comment					
Levee Evaluation Comments					
Description:Erosion commences halfway down the slope and results in slippage into the waterside toe. Existing rip rap has sloughed into the water side toe.					
Site ID No:393					
Site Designation:LMA-220					
Repair Type: Erosion					
Rating:Serious					
Field Date:7/20/2017					
Notes: Moderate sloughing 8ft from WS crown. Erosion at high water mark.

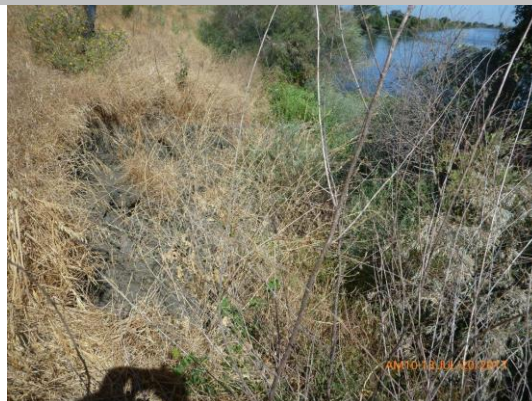
Photo 1 of 3 : FA_2019_RD2060_243_25_20190826_00026.jpg

LM Start	1.84	Rating **	M	Issue No.	25
LM End	1.92	Issue Type +	Ma	Location *	WS
Category	Supplemental		GPS Latitude/Longitude		
			Start	End	
Item	2017 Storm Damage		38.284825 °	38.284467 °	
			-121.721764 °	-121.720339 °	
DWR ID	LMA-222				
Comment Code					
Inspector Comment					
Levee Evaluation Comments Description: Erosion commences halfway down the slope and results in slippage into the waterside toe. Site ID No: 395 Site Designation: LMA-222 Repair Type: Erosion Rating: Area of Concern Field Date: 7/20/2017 Notes: Erosion halfway down slope. Monitor for progression.

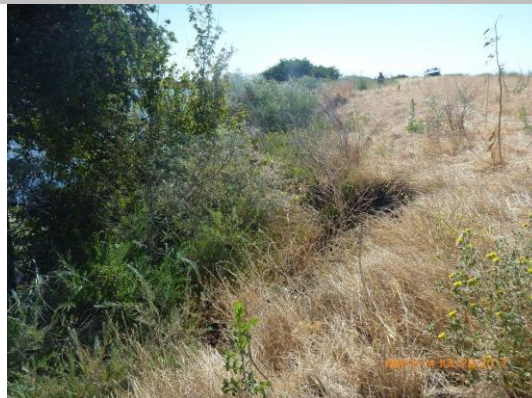
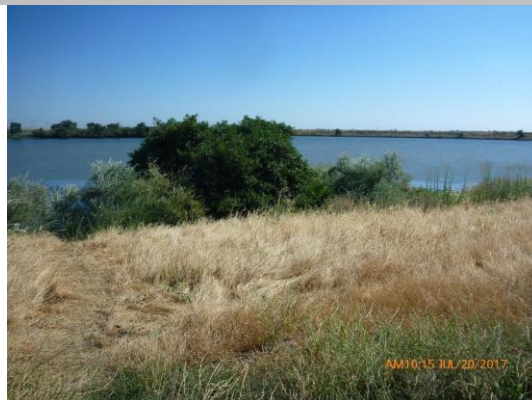
LM Start	1.84	Rating **	M	Issue No.	25 (cont)	
LM End	1.92	Issue Type +	Ma	Location *	WS	
Category	Supplemental			GPS Latitude/Longitude		
				Start		End
Item	2017 Storm Damage			38.284825 °		38.284467 °
				-121.721764 °		-121.720339 °
DWR ID	LMA-222					
Comment Code						
Inspector Comment						
Levee Evaluation Comments						
Description:Erosion commences halfway down the slope and results in						
slippage into the waterside toe.						
Site ID No:395						
Site Designation:LMA-222						
Repair Type: Erosion						
Rating:Area of Concern						
Field Date:7/20/2017						
Notes: Erosion halfway down slope. Monitor for progression.

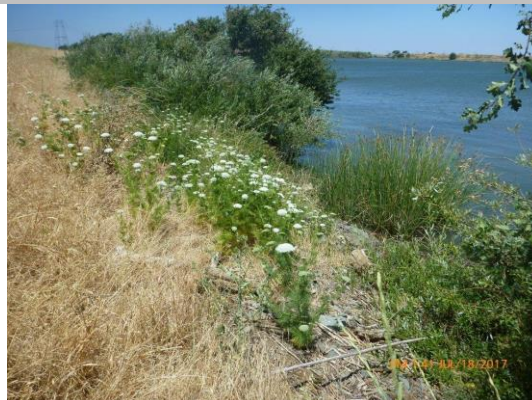
Photo 1 of 3 : FA_2019_RD2060_243_26_20190826_00029.jpg

LM Start	2.02	Rating **	M	Issue No.	26
LM End	2.06	Issue Type +	Ma	Location *	WS
Category	Supplemental			GPS Latitude/Longitude	
				Start	End
Item	2017 Storm Damage			38.283914 °	38.283422 °
				-121.718614 °	-121.718206 °
DWR ID	LMA-223				
Comment Code					
Inspector Comment					
Levee Evaluation Comments					
Description:Erosion commences halfway down the slope and results in					
slippage into the waterside toe. Existing rip rap has sloughed into the					
water side toe.					
Site ID No:396					
Site Designation:LMA-223					
Repair Type: Erosion					
Rating:Area of Concern					
Field Date:7/18/2017					
Notes: Erosion to high water line.

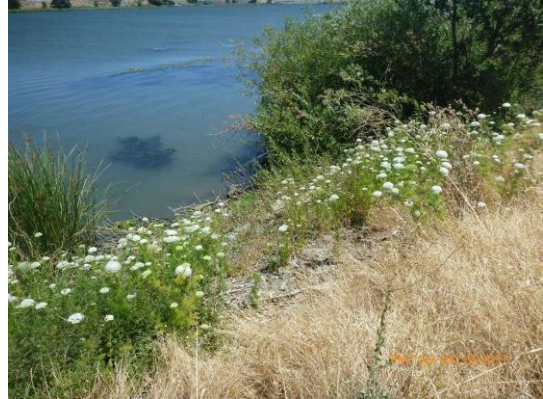
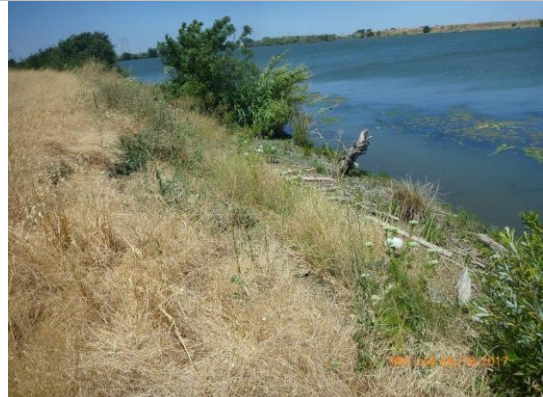
LM Start	2.02	Rating **	M	Issue No.	26 (cont)
LM End	2.06	Issue Type +	Ma	Location *	WS
Category	Supplemental			GPS Latitude/Longitude	
				Start	End
Item	2017 Storm Damage			38.283914 °	38.283422 °
				-121.718614 °	-121.718206 °
DWR ID	LMA-223				
Comment Code					
Inspector Comment					
Levee Evaluation Comments					
Description:Erosion commences halfway down the slope and results in slippage into the waterside toe. Existing rip rap has sloughed into the water side toe.					
Site ID No:396					
Site Designation:LMA-223					
Repair Type: Erosion					
Rating:Area of Concern					
Field Date:7/18/2017					
Notes: Erosion to high water line.

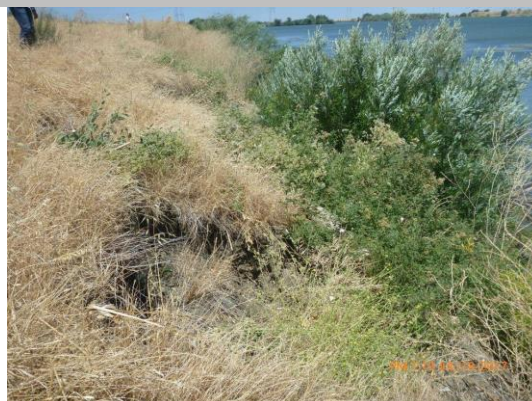
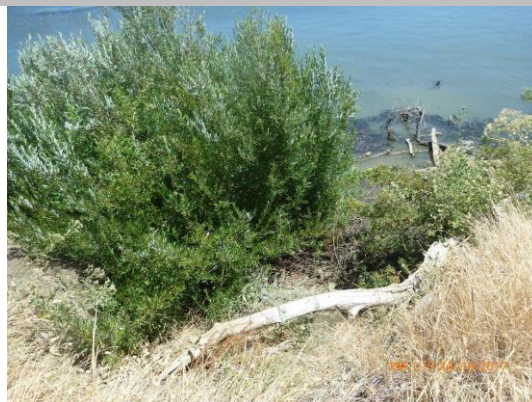
LM Start	2.12	Rating **	A/W	Issue No.	27
LM End	2.15	Issue Type +	Ma	Location *	WS
Category	Supplemental			GPS Latitude/Longitude	
				Start	End
Item	2017 Storm Damage			38.282733 °	38.282403 °
				-121.717683 °	-121.717428 °
DWR ID	LMA-224				
Comment Code					
Inspector Comment					
Levee Evaluation Comments					
Description:Erosion commences approximately 1/4 of the way down the slope and results in slippage into the waterside toe.					
Site ID No:397					
Site Designation:LMA-224					
Repair Type: Erosion					
Rating:Serious					
Field Date:7/18/2017					
Notes: Benched erosion with large cracks on slope above. Light veg in erosion.

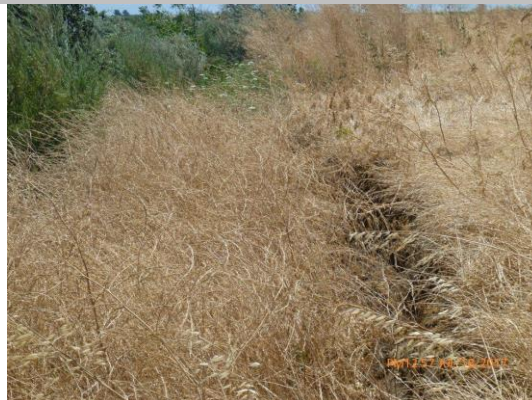
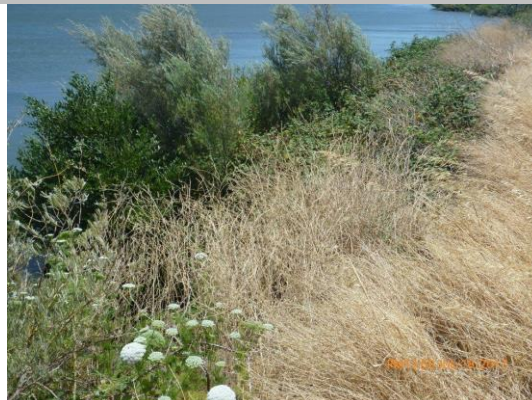
LM Start	2.19	Rating **	A/W	Issue No.	28 (cont)
LM End	2.22	Issue Type +	Ma	Location *	WS
Category	Supplemental			GPS Latitude/Longitude	
				Start	End
Item	2017 Storm Damage			38.281839 °	38.281486 °
				-121.716964 °	-121.716661 °
DWR ID	LMA-225				
Comment Code					
Inspector Comment					
Levee Evaluation Comments					
Description:Erosion commences approximately 1/4 of the way down the slope and results in slippage into the waterside toe.					
Site ID No:398					
Site Designation:LMA-225					
Repair Type: Erosion					
Rating:Serious					
Field Date:7/18/2017					
Notes: Erosion is near vertical with light veg. Existing rip rap to the left of site.

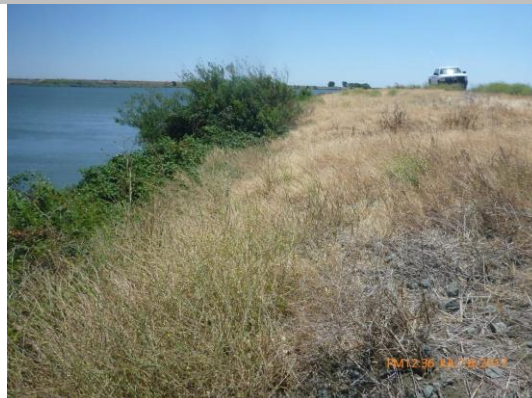
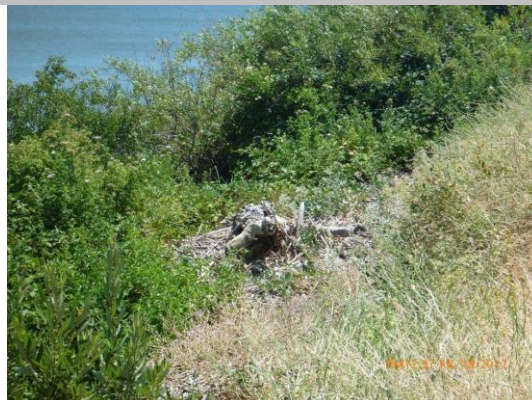
LM Start	2.30	Rating **	M	Issue No.	29
LM End	2.33	Issue Type +	Ma	Location *	WS
Category	Supplemental			GPS Latitude/Longitude	
				Start	End
Item	2017 Storm Damage			38.280667°	38.280467°
				-121.715664°	-121.715242°
DWR ID	LMA-226				
Comment Code					
Inspector Comment					
Levee Evaluation Comments					
Description:Erosion commences approximately halfway down the slope and results in slippage into the waterside toe.					
Site ID No:399					
Site Designation:LMA-226					
Repair Type: Erosion					
Rating:Area of Concern					
Field Date:7/18/2017					
Notes: Vertical erosion at high water mark.

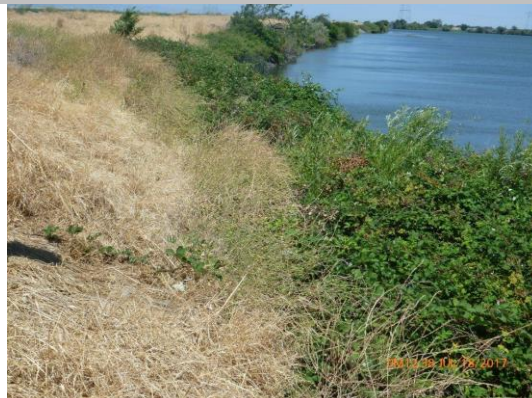
Photo 3 of 3 : FA_2019_RD2060_243_29_20190826_00040.jpg

LM Start	2.30	Rating **	M	Issue No.	29 (cont)
LM End	2.33	Issue Type +	Ma	Location *	WS
Category	Supplemental			GPS Latitude/Longitude	
				Start	End
Item	2017 Storm Damage			38.280667 °	38.280467 °
				-121.715664 °	-121.715242 °
DWR ID	LMA-226				
Comment Code					
Inspector Comment					
Levee Evaluation Comments					
Description:Erosion commences approximately halfway down the slope and results in slippage into the waterside toe.					
Site ID No:399					
Site Designation:LMA-226					
Repair Type: Erosion					
Rating:Area of Concern					
Field Date:7/18/2017					
Notes: Vertical erosion at high water mark.

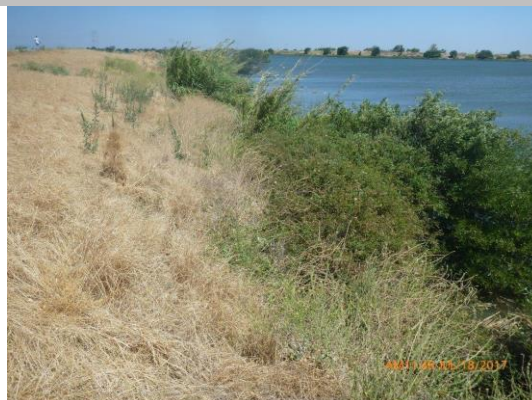
Photo 1 of 3 : FA_2019_RD2060_243_31_20190826_00041.jpg

LM Start	2.36	Rating **	M	Issue No.	31
LM End	2.43	Issue Type +	Ma	Location *	WS
Category	Supplemental			GPS Latitude/Longitude	
				Start	End
Item	2017 Storm Damage			38.280208 °	38.279336 °
				-121.714853 °	-121.714172 °
DWR ID	LMA-227				
Comment Code					
Inspector Comment					
Levee Evaluation Comments					
Description:Erosion commences approximately halfway down the slope and results in slippage into the waterside toe.					
Site ID No:400					
Site Designation:LMA-227					
Repair Type: Erosion					
Rating:Area of Concern					
Field Date:7/18/2017					
Notes: Steep cut but protected with heavy woody veg.

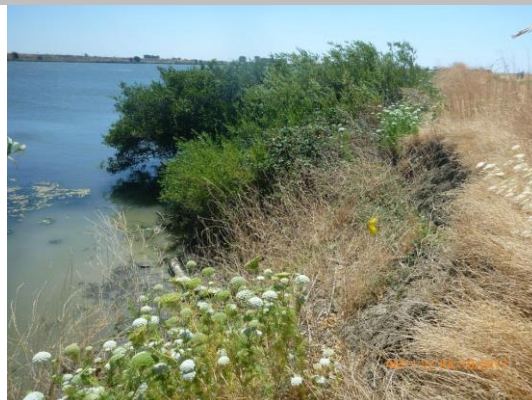
LM Start	2.36	Rating **	M	Issue No.	31 (cont)	
LM End	2.43	Issue Type +	Ma	Location *	WS	
Category	Supplemental			GPS Latitude/Longitude		
				Start		End
Item	2017 Storm Damage			38.280208 °		38.279336 °
				-121.714853 °		-121.714172 °
DWR ID	LMA-227					
Comment Code						
Inspector Comment						
Levee Evaluation Comments						
Description:Erosion commences approximately halfway down the slope and results in slippage into the waterside toe.						
Site ID No:400						
Site Designation:LMA-227						
Repair Type: Erosion						
Rating:Area of Concern						
Field Date:7/18/2017						
Notes: Steep cut but protected with heavy woody veg.

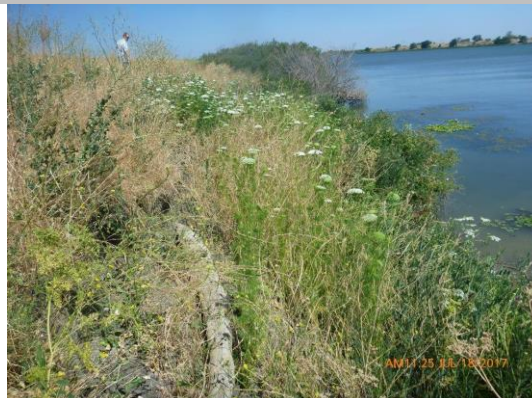
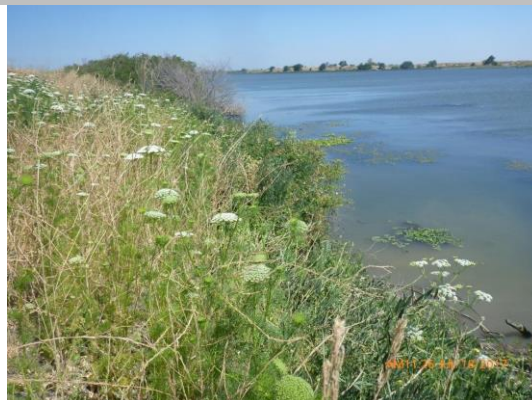
LM Start	2.47	Rating **	M	Issue No.	32
LM End	2.49	Issue Type +	Ma	Location *	WS
Category	Supplemental			GPS Latitude/Longitude	
				Start	End
Item	2017 Storm Damage			38.278794 °	38.278533 °
				-121.713703 °	-121.713453 °
DWR ID	LMA-228				
Comment Code					
Inspector Comment					
Levee Evaluation Comments					
Description:Erosion commences approximately halfway down the slope and results in sloughing into the waterside toe.					
Site ID No:401					
Site Designation:LMA-228					
Repair Type: Erosion					
Rating:Area of Concern					
Field Date:7/18/2017					
Notes: Erosion and sloughing. Heavy veg flanking both sides.

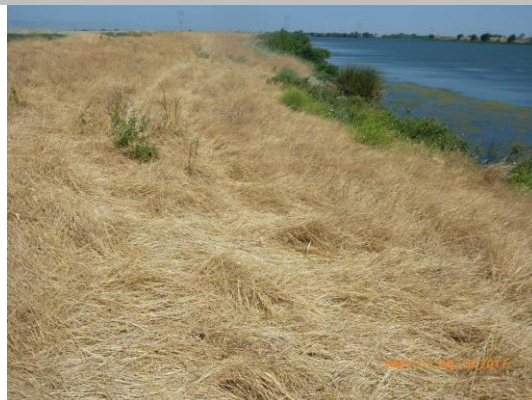
LM Start	2.55	Rating **	M	Issue No.	33 (cont)	
LM End	2.55	Issue Type +	Ma	Location *	WS	
Category	Supplemental			GPS Latitude/Longitude		
				Start		End
Item	2017 Storm Damage			38.277956 °		38.277928 °
				-121.712814 °		-121.712775 °
DWR ID	LMA-229					
Comment Code						
Inspector Comment						
Levee Evaluation Comments						
Description:Erosion commences approximately halfway down the slope and extends to the waterside toe.						
Site ID No:402						
Site Designation:LMA-229						
Repair Type: Erosion						
Rating:Area of Concern						
Field Date:7/18/2017						
Notes: Small but deep vertical cut down to water.

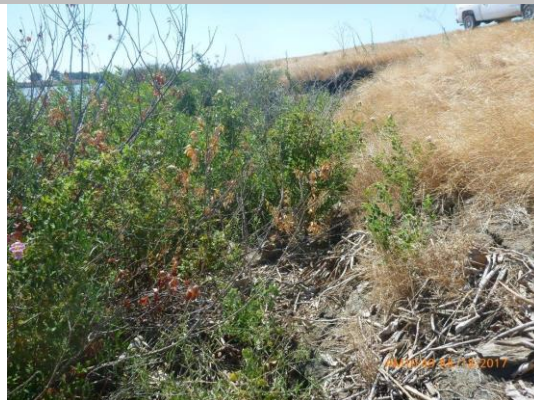
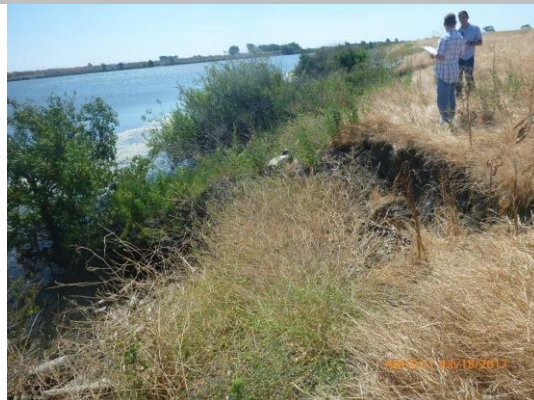
LM Start	2.56	Rating **	A/W	Issue No.	34
LM End	2.58	Issue Type +	Ma	Location *	WS
Category	Supplemental			GPS Latitude/Longitude	
				Start	End
Item	2017 Storm Damage			38.277850 °	38.277706 °
				-121.712639 °	-121.712414 °
DWR ID	LMA-230				
Comment Code					
Inspector Comment					
Levee Evaluation Comments					
Description:Erosion commences approximately 1/4 of the way down the slope and results in sloughing into the waterside toe.					
Site ID No:403					
Site Designation:LMA-230					
Repair Type: Erosion					
Rating:Serious					
Field Date:7/18/2017					
Notes: Erosion causing sloughing. Horizontal cracks about 6' up from erosion.

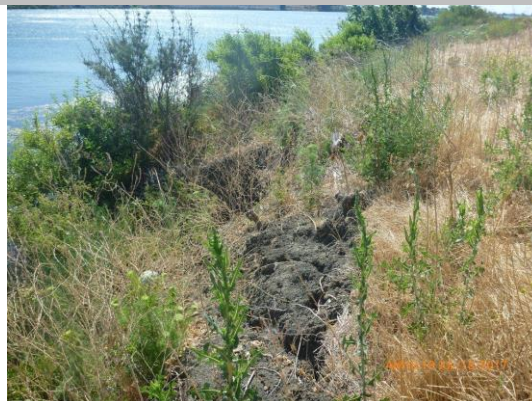
Photo 1 of 3 : FA_2019_RD2060_243_35_20190826_00053.jpg

LM Start	2.64	Rating **	M	Issue No.	35
LM End	2.64	Issue Type +	Ma	Location *	WS
Category	Supplemental			GPS Latitude/Longitude	
				Start	End
Item	2017 Storm Damage			38.277106 °	38.277078 °
				-121.711489 °	-121.711447 °
DWR ID	LMA-231				
Comment Code					
Inspector Comment					
Levee Evaluation Comments					
Description:Erosion commences approximately 1/4 of the way down the slope and results in sloughing into the waterside toe.					
Site ID No:404					
Site Designation:LMA-231					
Repair Type: Erosion					
Rating:Area of Concern					
Field Date:7/18/2017					
Notes: Small erosion and sloughing adjacent to revetted slope.

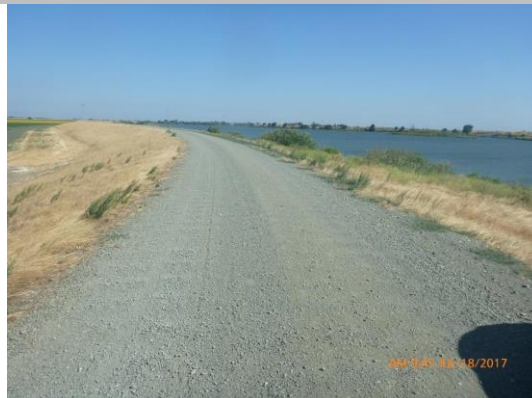
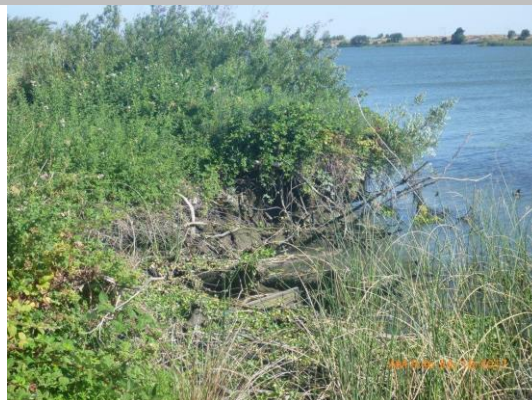
LM Start	2.69	Rating **	A/W	Issue No.	36
LM End	2.73	Issue Type +	Ma	Location *	WS
Category	Supplemental			GPS Latitude/Longitude	
				Start	End
Item	2017 Storm Damage			38.276608 °	38.276133 °
				-121.710811 °	-121.710394 °
DWR ID	LMA-232				
Comment Code					
Inspector Comment					
Levee Evaluation Comments					
Description:Sloughing commences approximately halfway down the slope and extends to the waterside toe.					
Site ID No:405					
Site Designation:LMA-232					
Repair Type: Erosion					
Rating:Serious					
Field Date:7/18/2017					
Notes: Vertical cut at highwater mark.

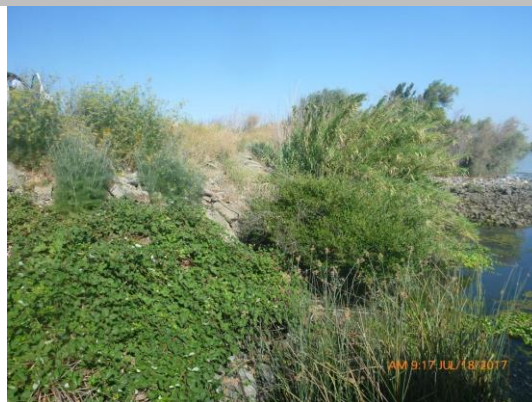
Photo 1 of 3 : FA_2019_RD2060_243_37_20190826_00059.jpg

LM Start	3.24	Rating **	M	Issue No.	37
LM End	3.24	Issue Type +	Ma	Location *	WS
Category	Supplemental			GPS Latitude/Longitude	
				Start	End
Item	2017 Storm Damage			38.270231 °	38.270203 °
				-121.705897 °	-121.705856 °
DWR ID	LMA-233				
Comment Code					
Inspector Comment					
Levee Evaluation Comments					
Description:Erosion commences approximately halfway down the slope and results in sloughing into the waterside toe. Existing rip rap has been pulled off the slope at this site.					
Site ID No:406					
Site Designation:LMA-233					
Repair Type: Erosion					
Rating:Area of Concern					
Field Date:7/18/2017					
Notes: Erosion is next to a pumphouse and slope is protected with rip rap.

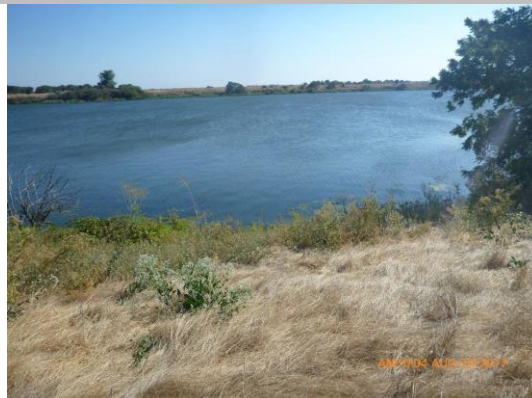
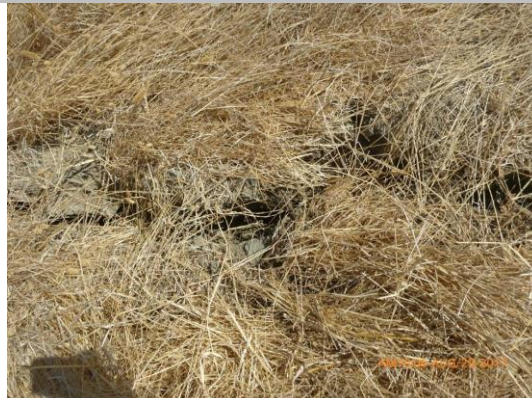
LM Start	3.59	Rating **	M	Issue No.	38	
LM End	3.63	Issue Type +	Ma	Location *		
Category	Supplemental			GPS Latitude/Longitude		
				Start	End	
Item	2017 Storm Damage			38.266408 °	38.266047 °	
				-121.701650 °	-121.701061 °	
DWR ID	LMA-322					
Comment Code						
Inspector Comment						
Levee Evaluation Comments						
Description:MBK Delta Erosion Sites_6-29-2017						
Site ID No:484						
Site Designation:LMA-322						
Repair Type: Erosion						
Rating:Area of Concern						
Field Date:8/29/2017						
Notes:

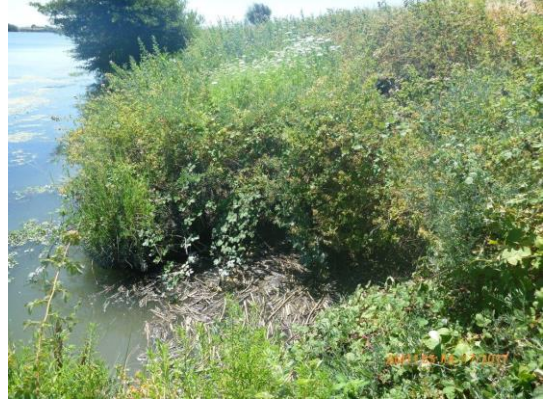
Photo 3 of 3 : FA_2019_RD2060_243_42_20190826_00073.jpg

LM Start	4.06	Rating **	A/W	Issue No.	42 (cont)	
LM End	4.08	Issue Type +	Ma	Location *	WS	
Category	Supplemental			GPS Latitude/Longitude		
				Start	End	
Item	2017 Storm Damage			38.260789 °	38.260644 °	
				-121.696964 °	-121.696828 °	
DWR ID	LMA-239					
Comment Code						
Inspector Comment						
Levee Evaluation Comments						
Description:Erosion commences approximately halfway down the slope and results in sloughing into the waterside toe. Existing rip rap has been pulled off the slope at this site.						
Site ID No:412						
Site Designation:LMA-239						
Repair Type: Erosion						
Rating:Serious						
Field Date:7/17/2017						
Notes: Small erosion. Appears that site grows slowly with each high water. The center of the eosion is a deep cut that extends below rhe waterline. Possible beaver den collapse.
